#### Characteristics of damage caused by exceeding the release travel

#### Causes for exceeding the release travel provided in the design (> A)

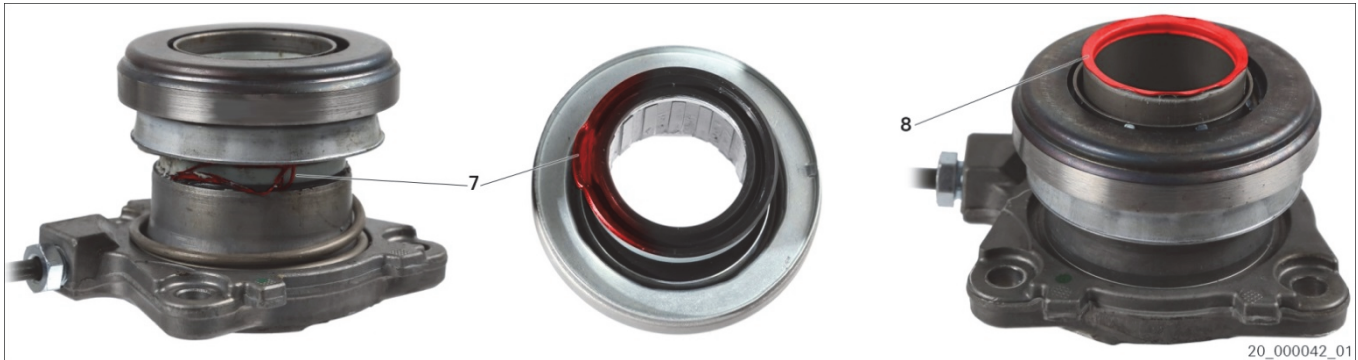
Fig. 2: Lipped seal ring is sheared

Fig. 3: Lipped seal ring is everted

Fig. 4: Transport safety device is rippled

Exceeding the release travel (> A) always results in damage to the CSC. Depending on the CSC model, the following characteristics or damage may be present:

- Lipped seal ring (7) sheared (Fig. 2)
- Lipped seal ring (7) everted (Fig. 3)
- Transport safety device is rippled, funnel-shaped, loose or torn (Fig. 4)
- Housing is cracked or broken.

➔ Comply with service information:

Concentric slave cylinder (CSC) - Causes of leakage (12040 EN).
